**DEPARTMENT OF TRANSPORTATION****DIVISION OF ENGINEERING SERVICES**

Quality Assurance and Source Inspection

Contract #: 04-0120F4Cty: SF/ALA Rte: 80 PM: 13.2/13.9File #: 1.28**WELDING INSPECTION REPORT****Resident Engineer:** Pursell, Gary**Address:** 333 Burma Road**City:** Oakland, CA 94607**Report No:** WIR-015253**Date Inspected:** 30-Jun-2010**Project Name:** SAS Superstructure**OSM Arrival Time:** 1000**Prime Contractor:** American Bridge/Fluor Enterprises, a JV**OSM Departure Time:** 1830**Contractor:** American Bridge/Fluor Enterprises, a JV**Location:** Job Site

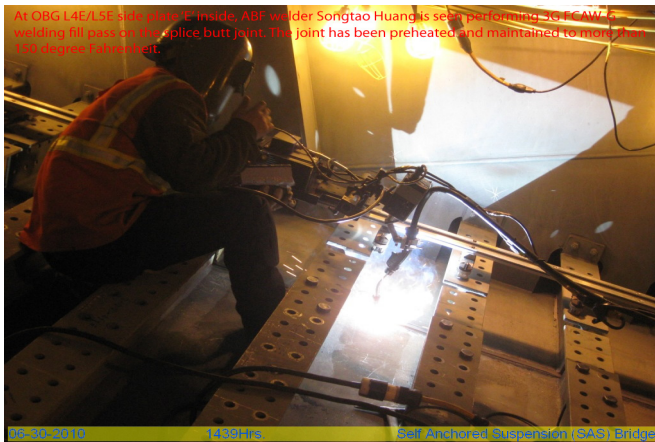
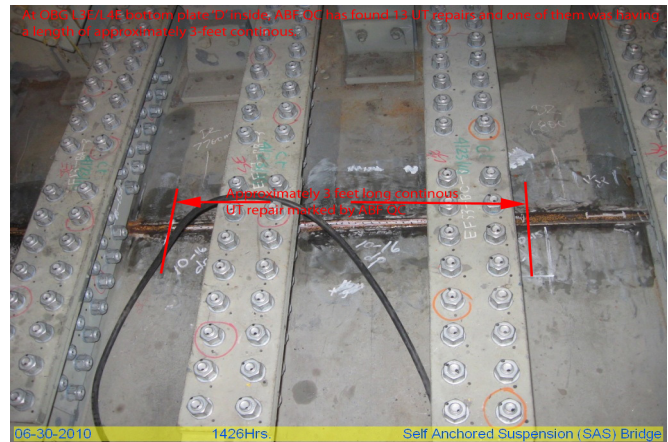
At OBG L3E/L4E bottom plate 'D' inside, QA randomly observed ABF QC Jesse Cayabyab continue perform Ultrasonic Testing (UT) on the welded splice butt joint. QC Jesse Cayabyab continued UT where he left yesterday and finished the remaining weld. During the UT, QC Jesse Cayabyab found 4 more repairs with one repair having a length of 36 inches. After the UT completion from the inside, QA noted QC Jesse Cayabyab moving to the outside of the same plate. But due to the elevated position of the splice butt joint from the outside and the unavailability of scaffold platform, QC said to wait doing the UT until the platform is ready.

At OBG L3E/L4E bottom plate 'D' inside, ABF QC Jesse Cayabyab informed QA that they found nine UT repairs by scanning from the inside. According to QC, they will continue to UT scan tomorrow and then move outside the OBG to scan from the opposite side of the plate.
